NASA-CR 135303

FINAL REPORT

DEVELOPMENT OF SPIRAL-GROOVE SELF-ACTING FACE SEALS

**AVCO LYCOMING DIVISION
550 South Main Street
Stratford, Connecticut 06497**

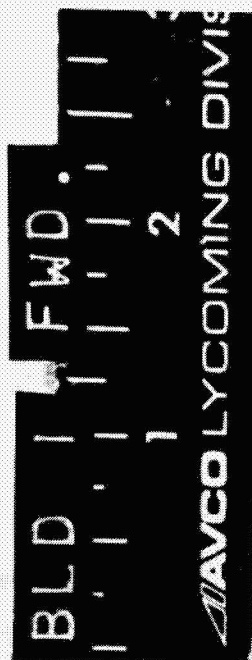
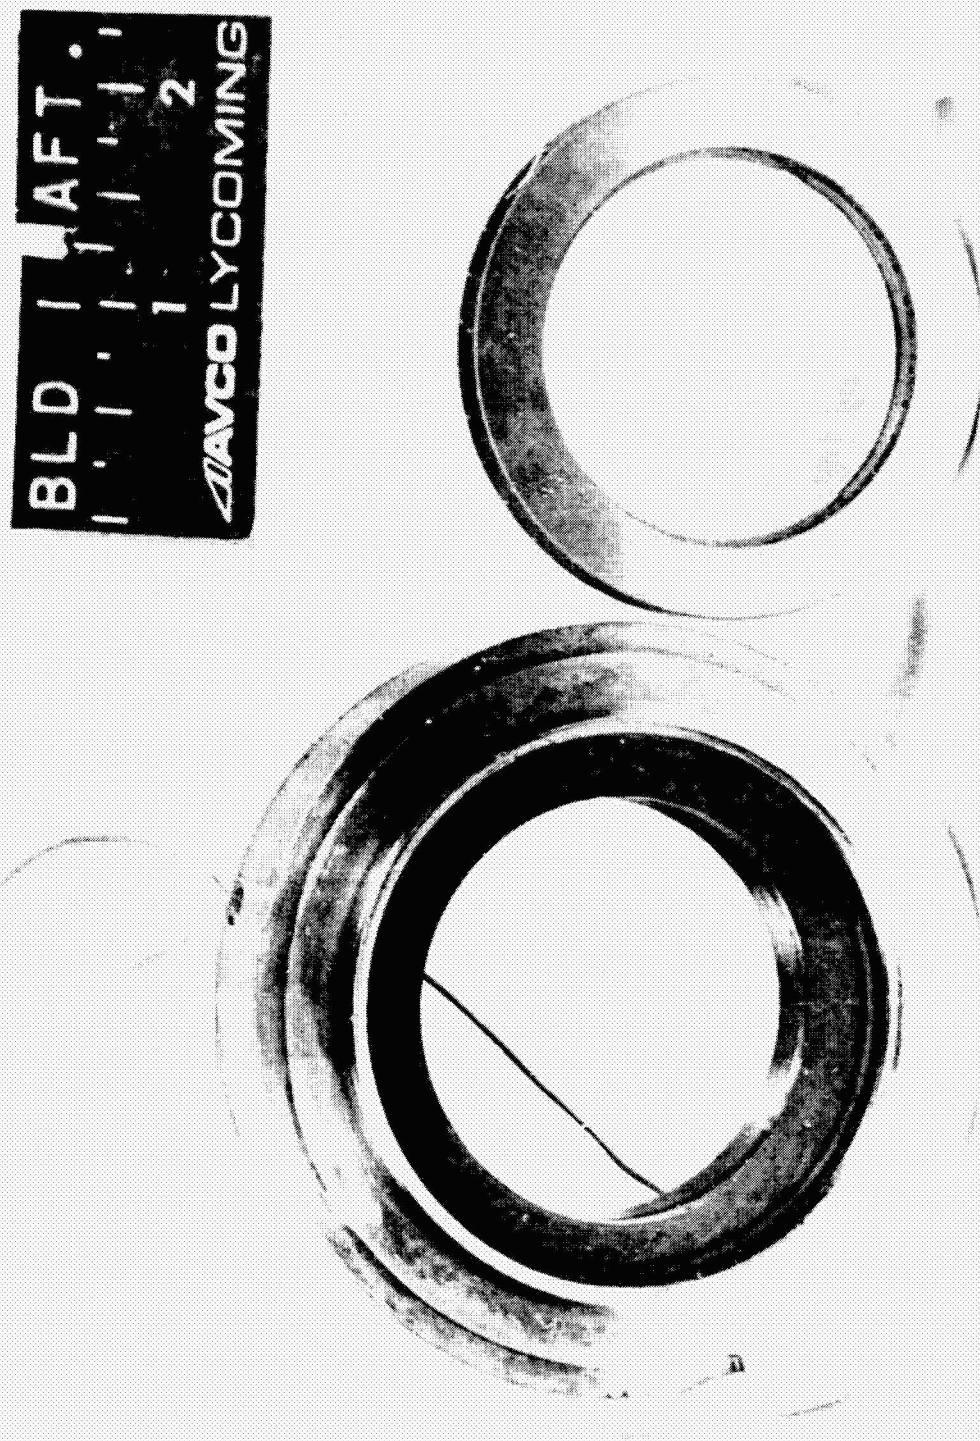
Wear was found to be greatest and the appearance of rubbing most evident near the ID of the face. Wear of the sealing dam was uniform and very light in comparison with that experienced in previous programs (Reference 1). Figures 18 and 19 show the forward and aft seal assemblies after test. Close-up views of the spiral grooves and seats are shown in Figures 20 through 23.

Figure 18. Forward Seal and Seat After Build I Testing.

Figure 19. Aft Seal and Seat After Build I Testing.

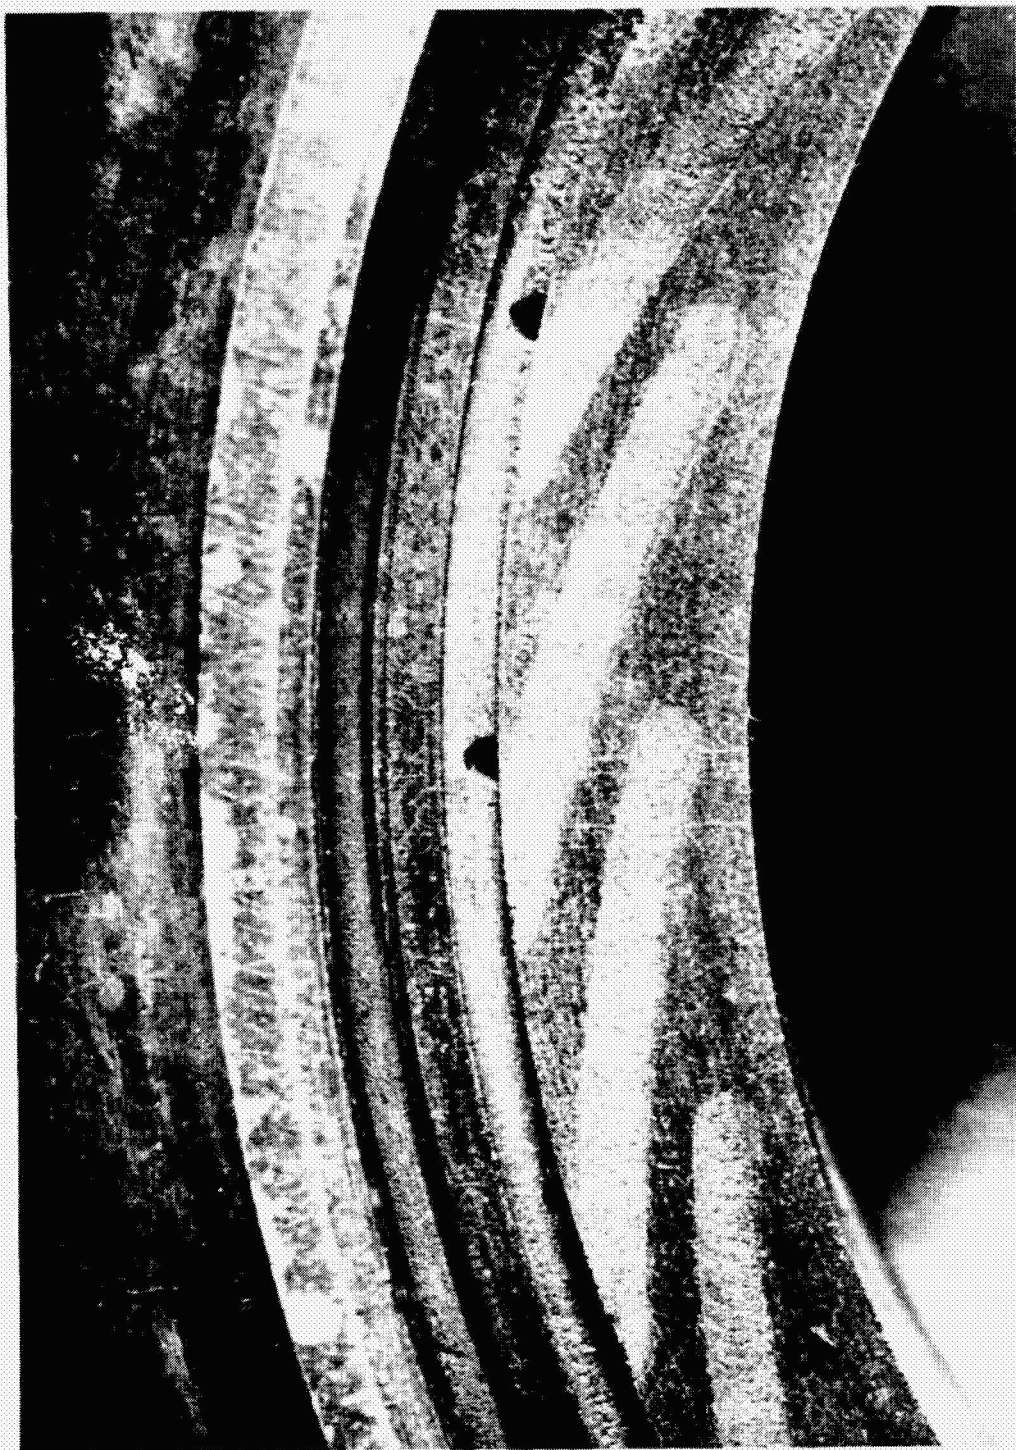
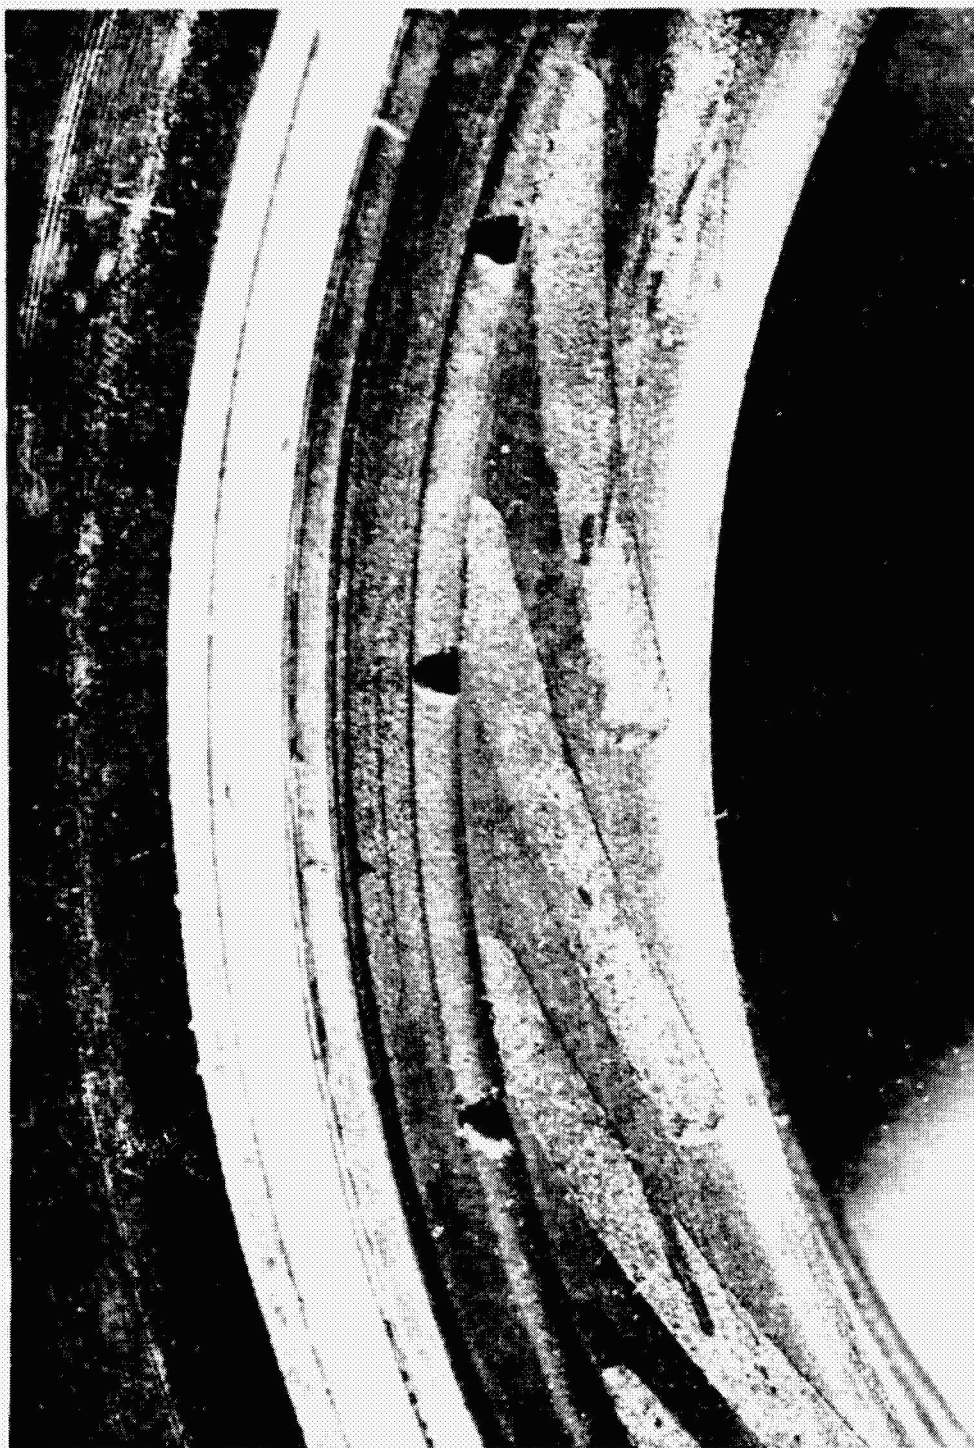
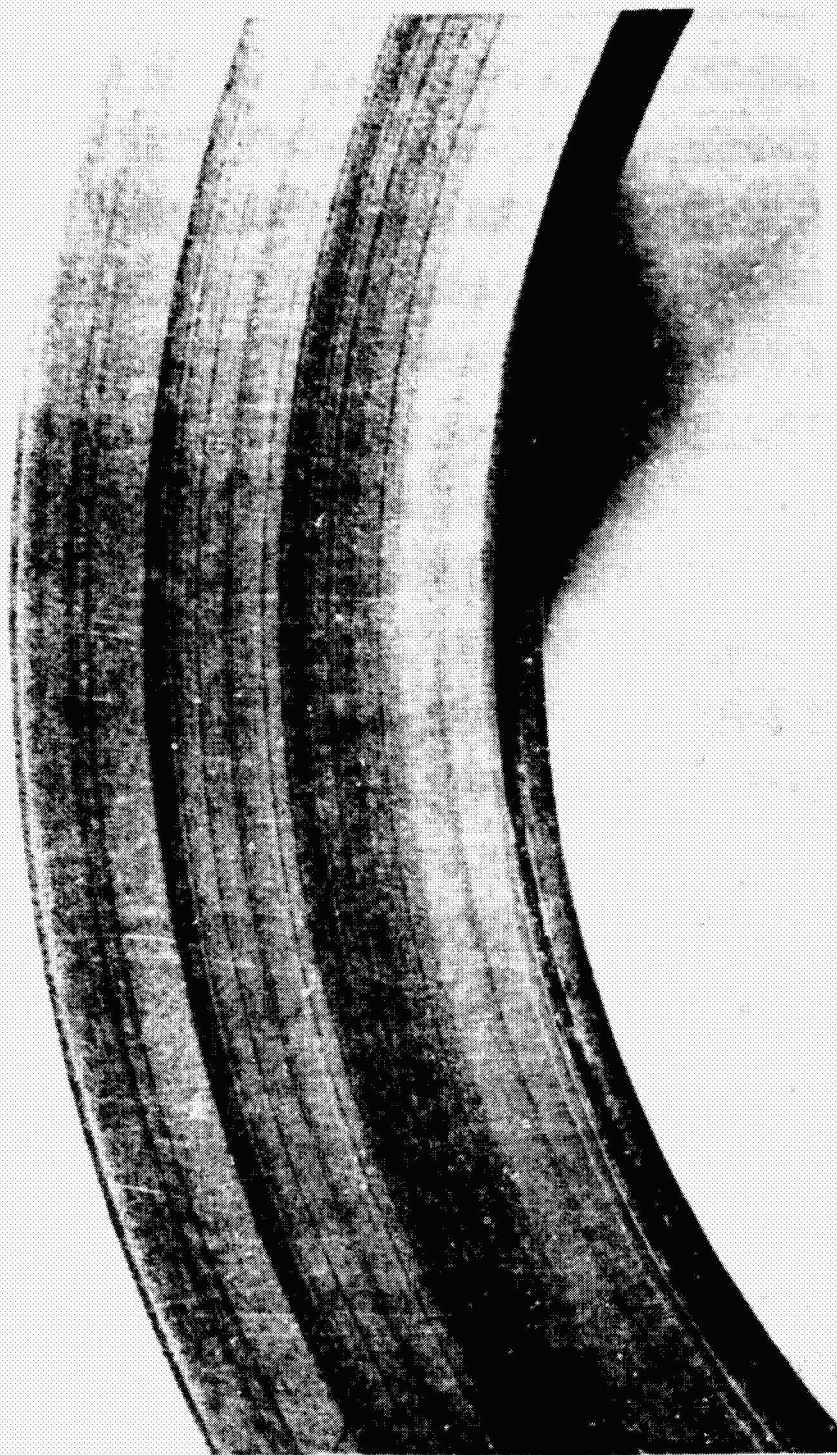
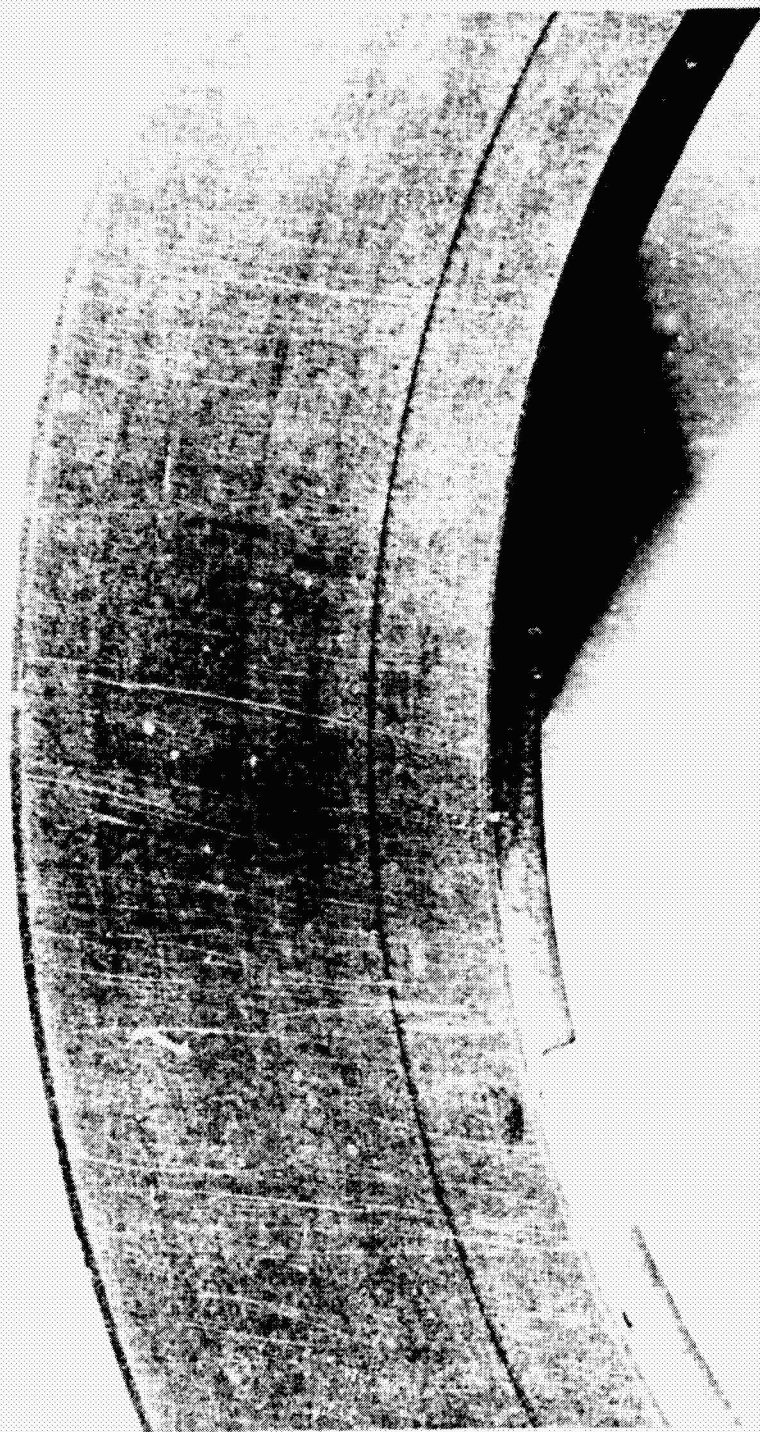
Figure 20. Forward Seal Spiral Grooves After Build I Testing.

Figure 21. Aft Seal Spiral Grooves After Build I Testing.

Figure 22. Forward Seal Seal After Build I Testing.

Figure 23. Aft Seal Seat After Build I Testing.

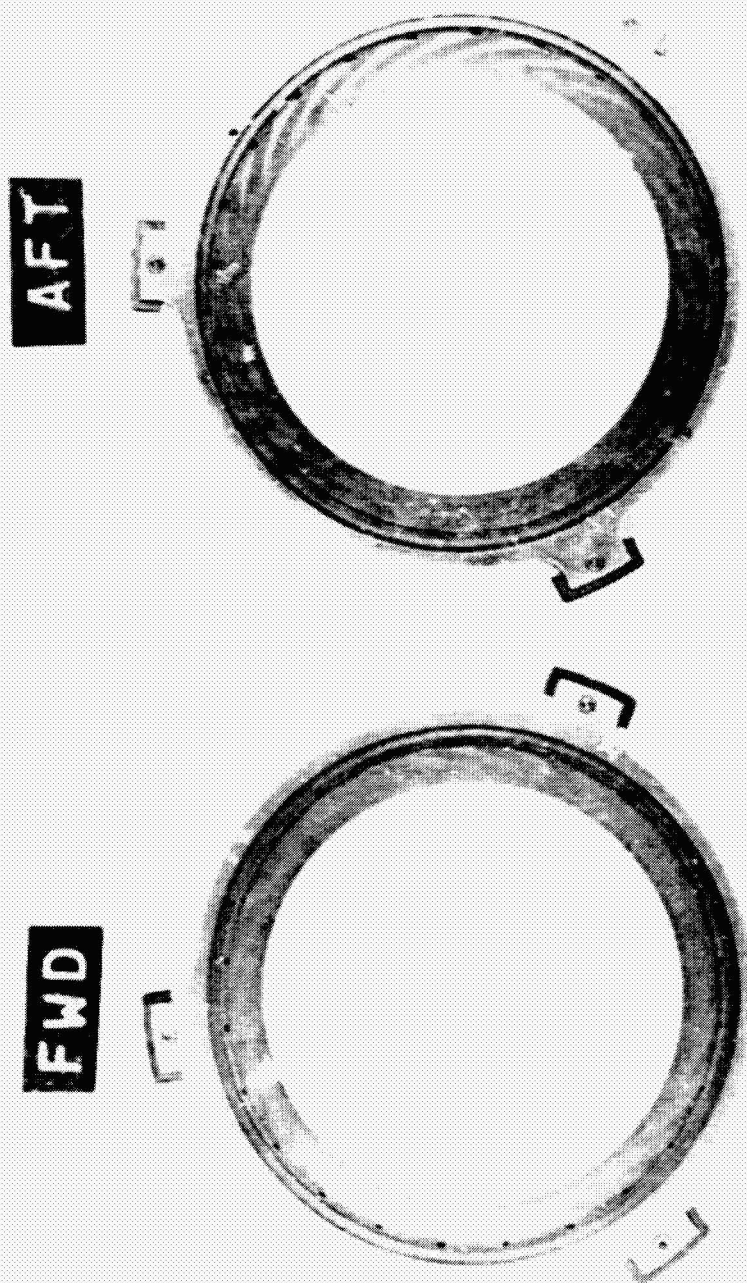
The forward sealing element experienced extremely heavy wear operation under this condition. The aft seal experienced heavy wear also but appeared to be in good condition, despite operation with the loose seat. Initial spiral groove depth of the aft seal was .00287 cm (.00113 in.) compared to .001349 cm (.00055 in.) depth of the forward seal groove. Because of the initially deeper grooves, the aft seal was still usable despite the wear. Observed seal wear was as follows:

Figure 24 illustrates the forward and aft sealing elements after Build II testing. Figure 25 illustrated the back (normally nonsealing side) of seal seats with the forward seat illustrating contact marks from sealing element due to it being reversed. A wear ring on the aft seat, caused by unclamped operation can be seen. Figure 26 shows the opposite side (normally the sealing side) of the seats (contact side for aft seat). The forward sealing element, exhibiting heavy wear and shallow spiral-groove geometry, was replaced with a new part of Build III testing. Table IV illustrates changes in face dimensions after Build II testing.

Figure 24. Forward and Aft Sealing Elements After
Build II Testing.

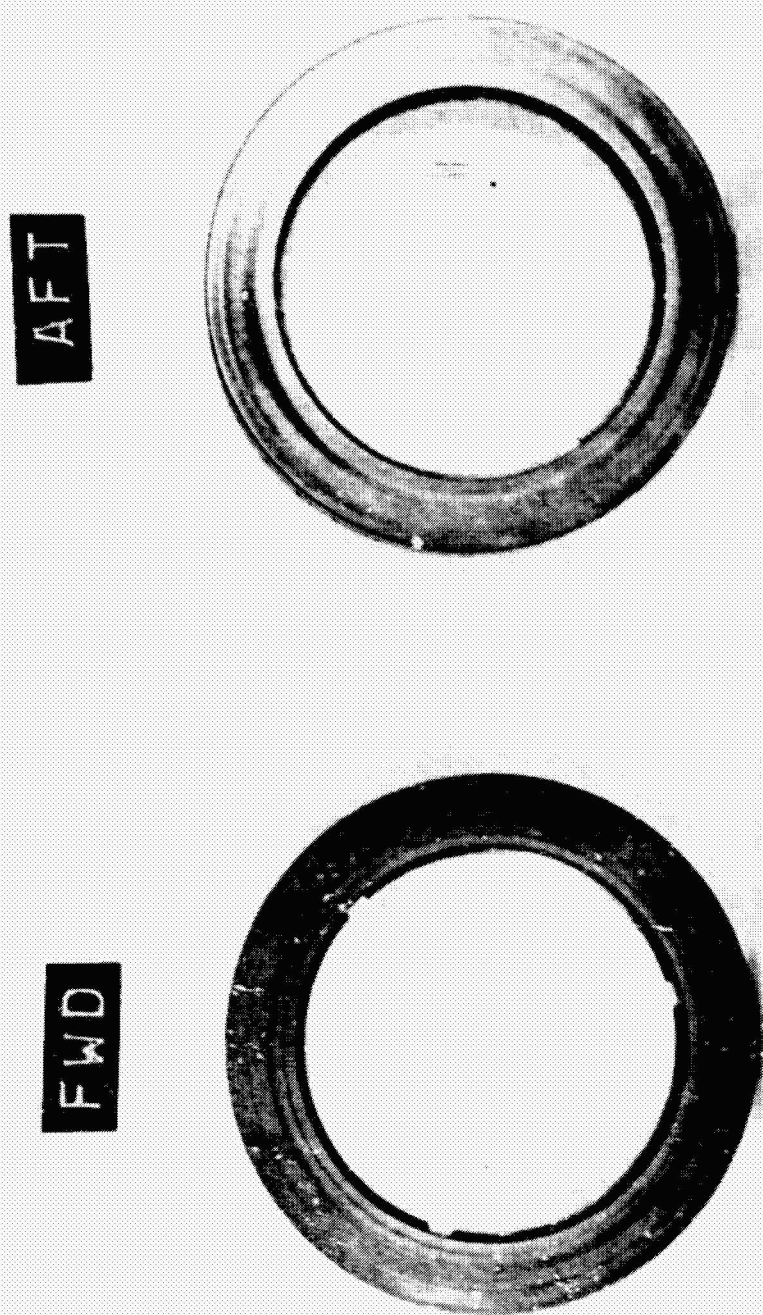
Figure 26. Front of Seal Seats After Build II Testing

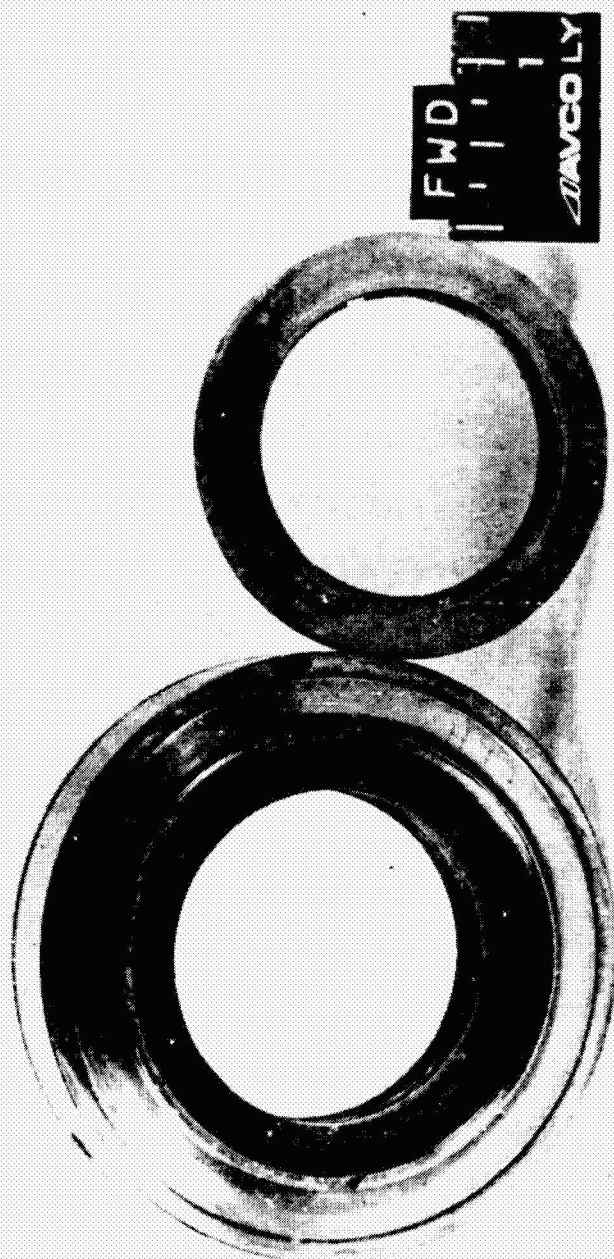
The post-test condition of the seals was documented in Figure 31 and 32. Changes in the seal face dimensions after Build III testing were measured with the following average wear results:

Figure 31. Forward Seal After Build III Testing.

Maximum wear occurred at the surface near the ID of the sealing element. Average remaining groove depth (self-acting mechanism) was .002570 cm (.000101 in.) for the forward seal and .003030 cm (.001190 in.) for the aft seal. Face dimensions are summarized in Table VI.

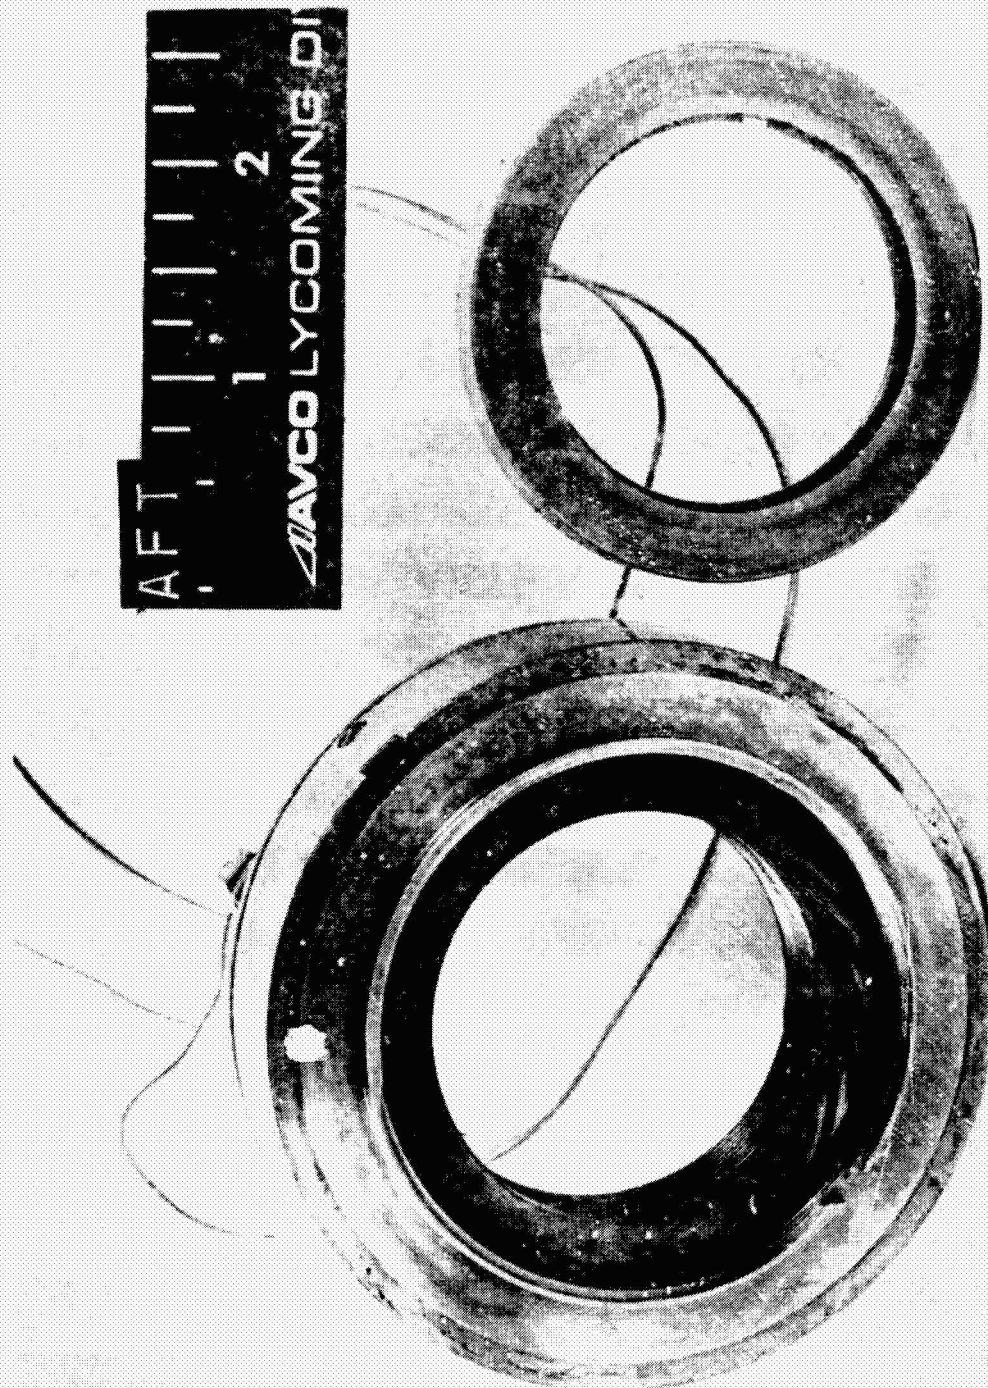
Figure 32. Aft Seal After Build III Testing.

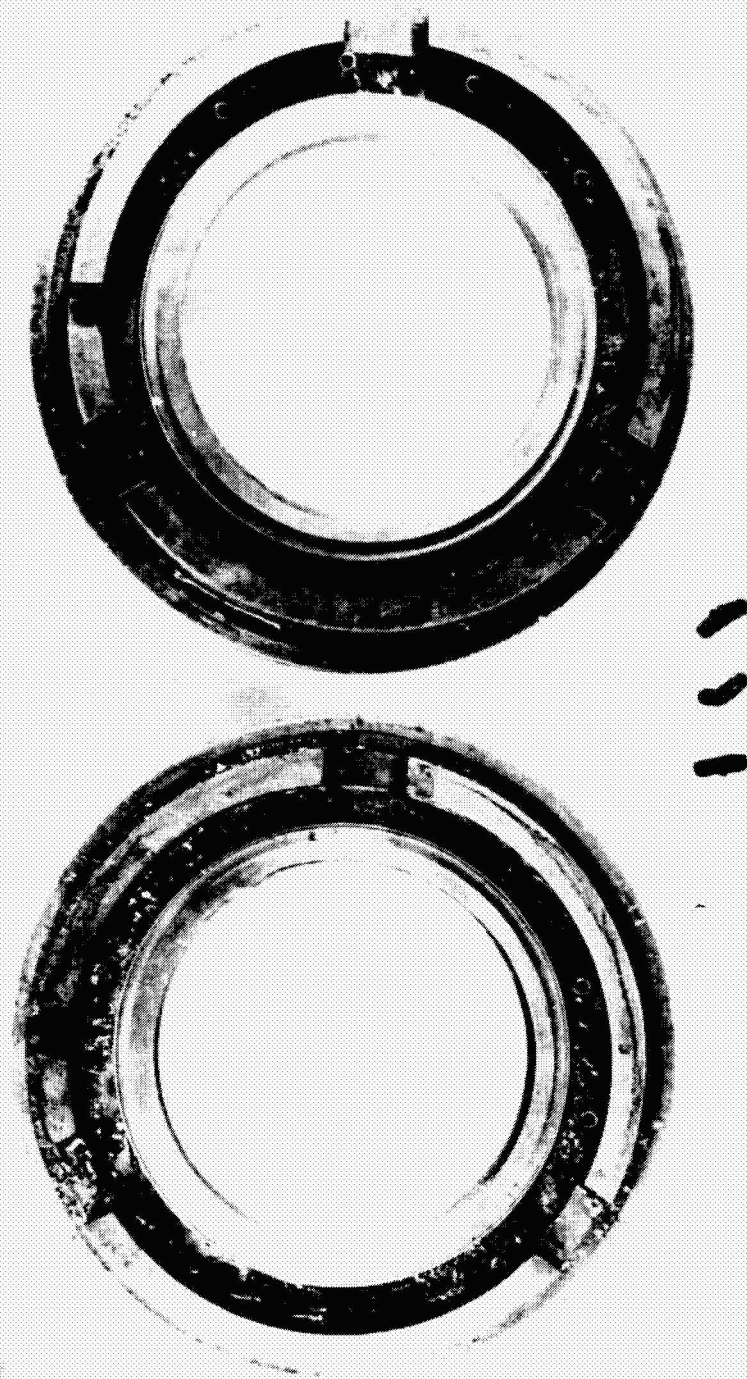
The endurance test encompassed 100.2 hours of operation at surface speeds to 243 m/s (800 ft/sec), sealed pressure to 148.14 N/cm² abs (215 psia), and sealed air temperatures of 645.4 K (702°F). A summary of the data points run is presented in Table VII. A test rig bearing problem necessitated interruption of the endurance test after 45 hours of operation. The test rig was rebuilt and seal hardware (seats, piston ring carriers, piston rings, and primary sealing elements) was changed. The damaged seal assemblies are pictured in Figures 23 through 38. During the failure, the seal seats contacted the seal housing, and the shaft rubbed the ID of the carbon sealing elements. The spiral-groove geometry remained intact except for radial cracks. Wear data was obtained but may have been influenced by the failure. These data are presented in Table VIII. Inspection of the seal housings revealed substantial oil coking within the housings and on some of the compression springs, tending to clog the coils. The interior of both seal housings and some typical coked springs are shown in Figure 38. The piston

Figure 38. Coking of Housing and Springs After Endurance Test,
Build I.

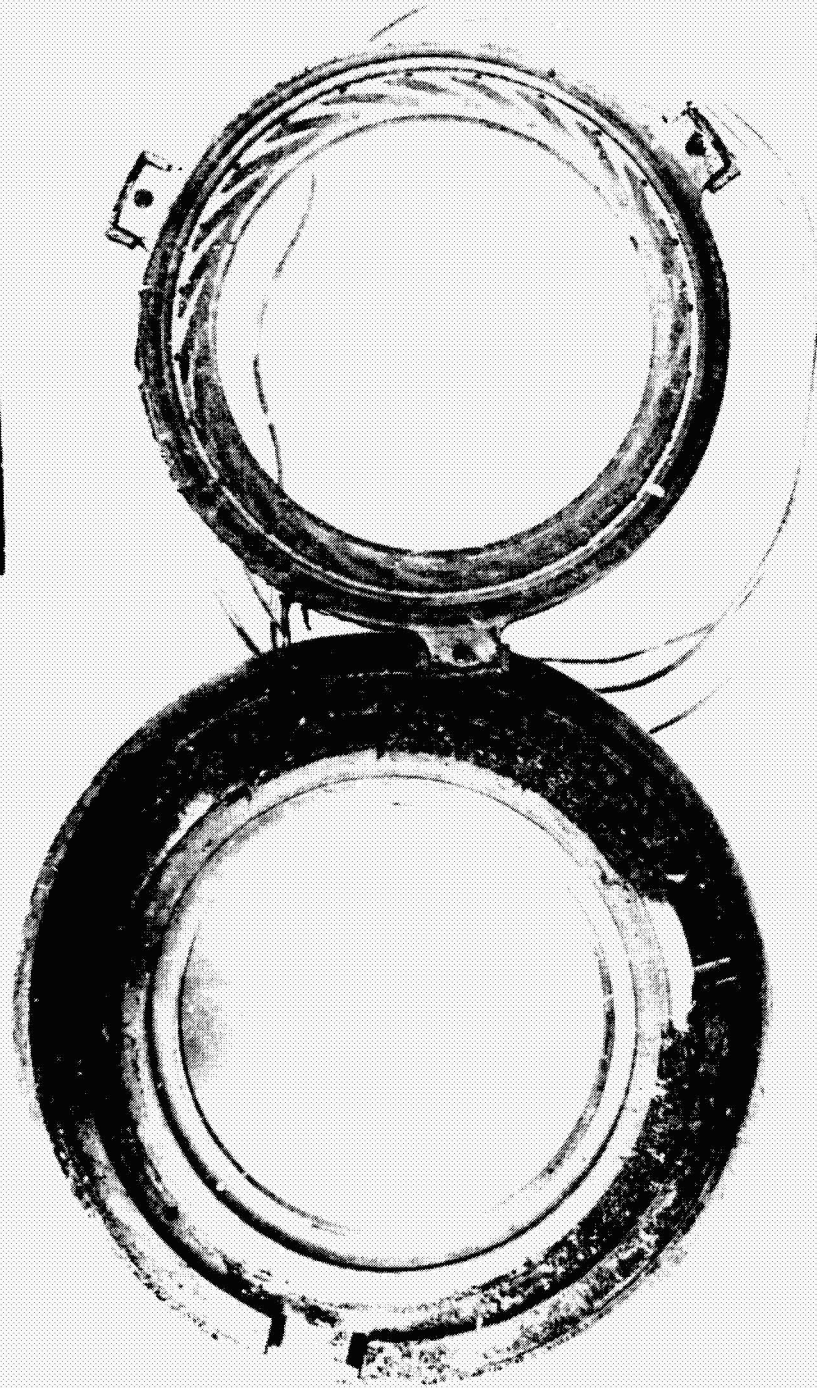
Figure 40. Internal Coking of Forward Seal After Endurance Test, Build II.

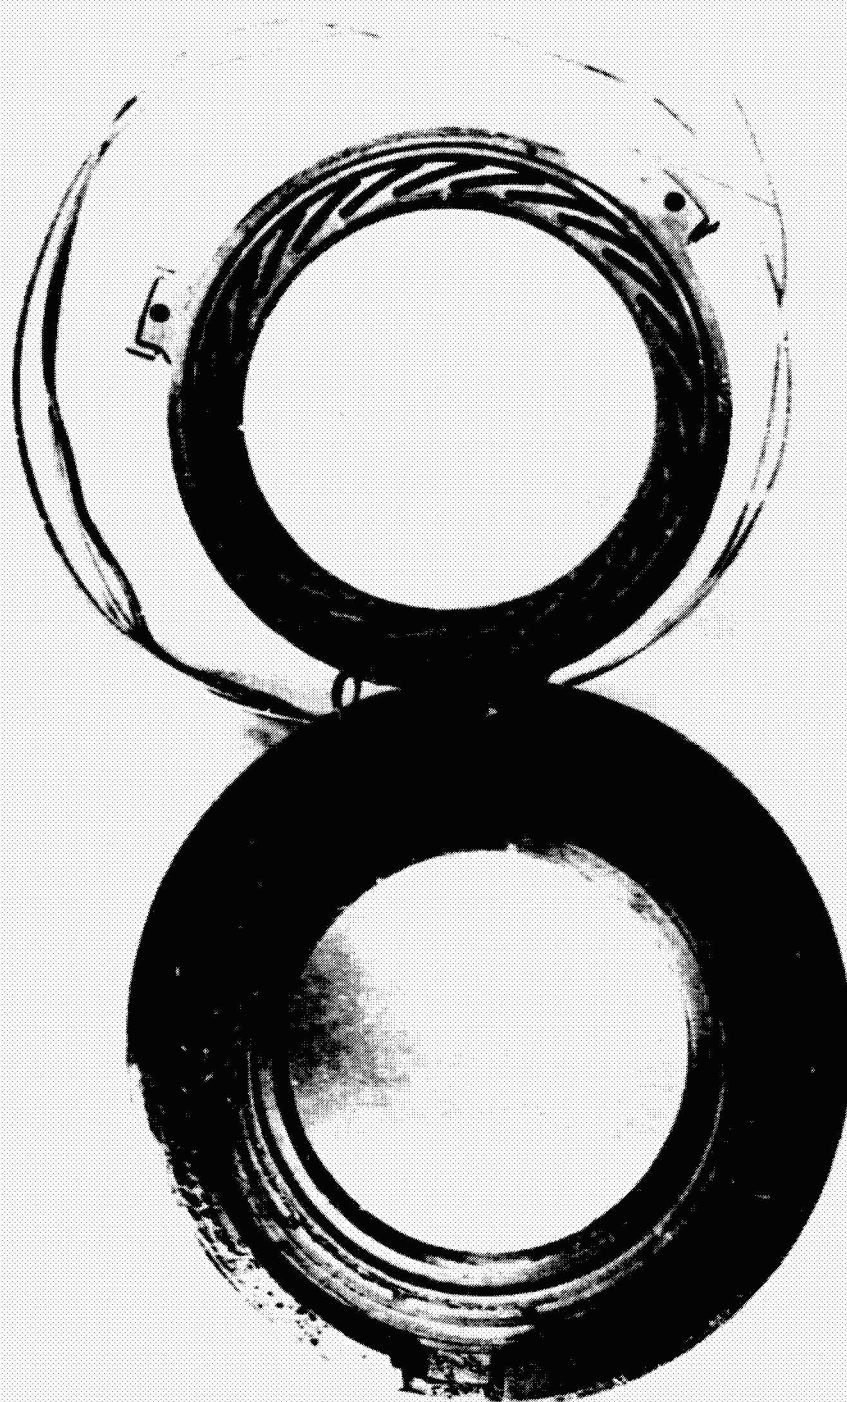
Figure 41. Internal Coking of Aft Seal After Endurance Test, Build II.

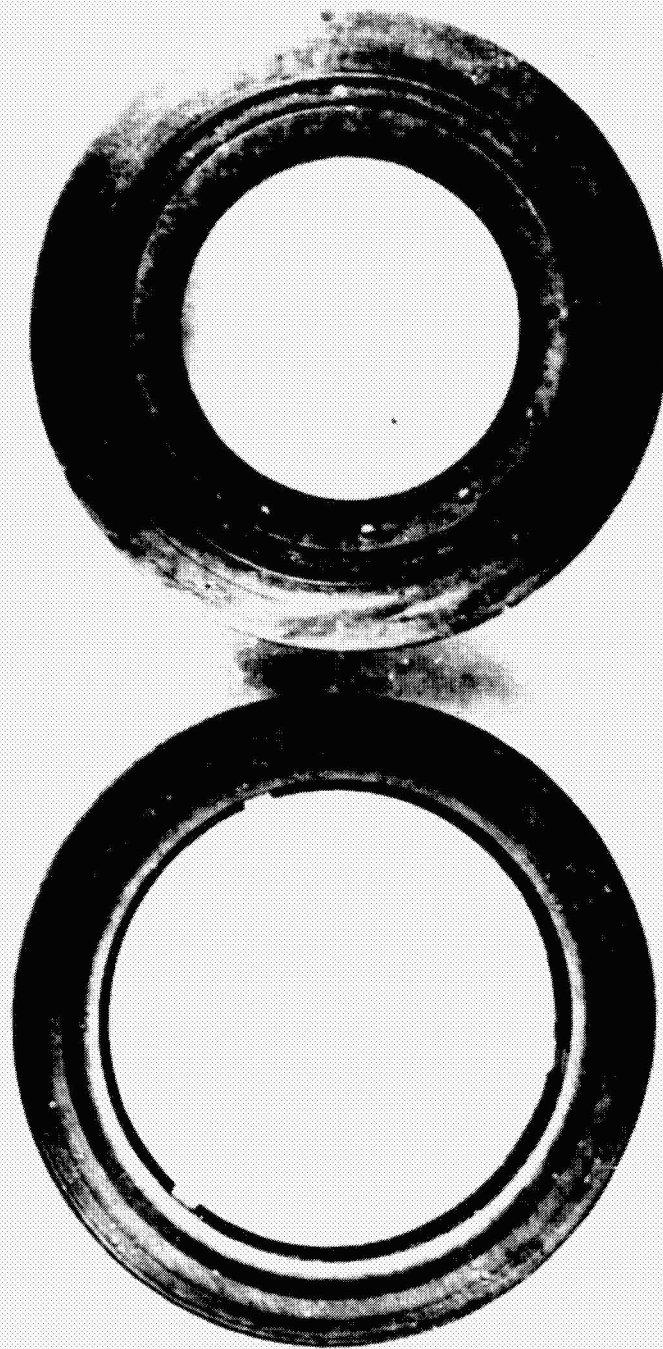
The seal seats exhibited radial cracks in the chrome carbide surface coating originating at the seat ID. The seats were otherwise in good condition as exhibited in Figures 44 and 45.

Figure 44. Forward Seal Seat and Dam After Endurance Test,
Build II.

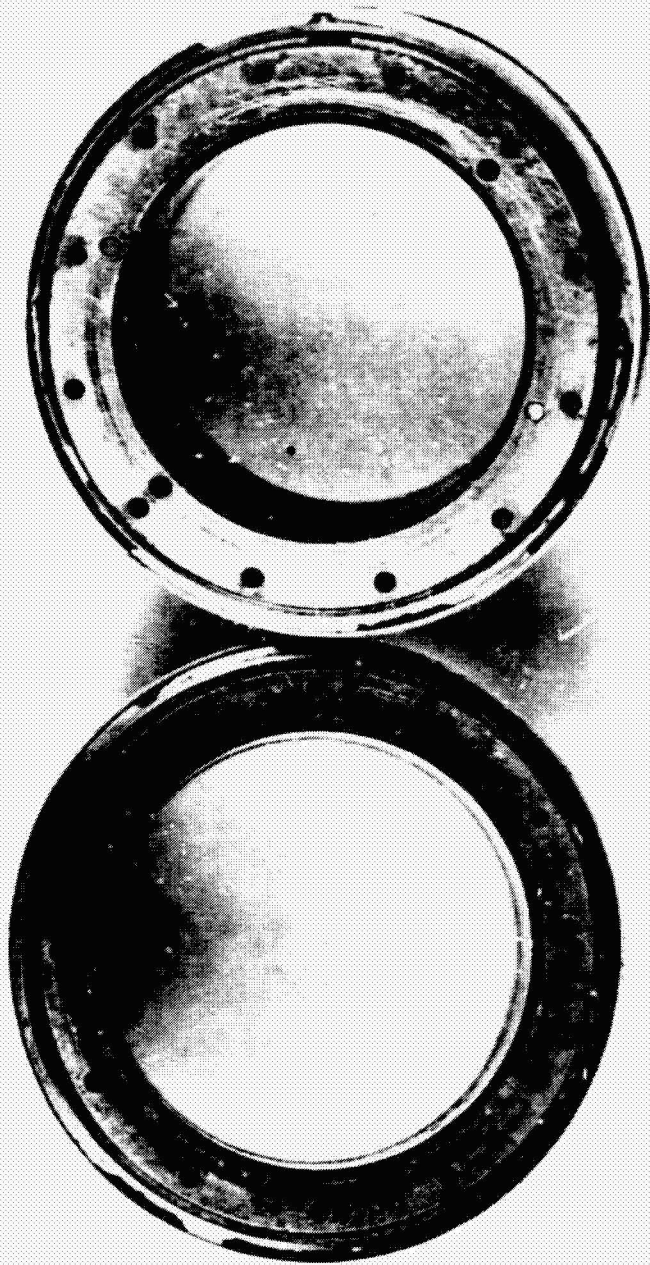
The bellows clamping spacers acted as centrifugal separators for small particulate matter in the seat cooling oil. The deposits can be seen in Figure 47.

Figure 47. Forward and Aft Windbacks With Bellows Spacers
After Endurance Test, Build II.

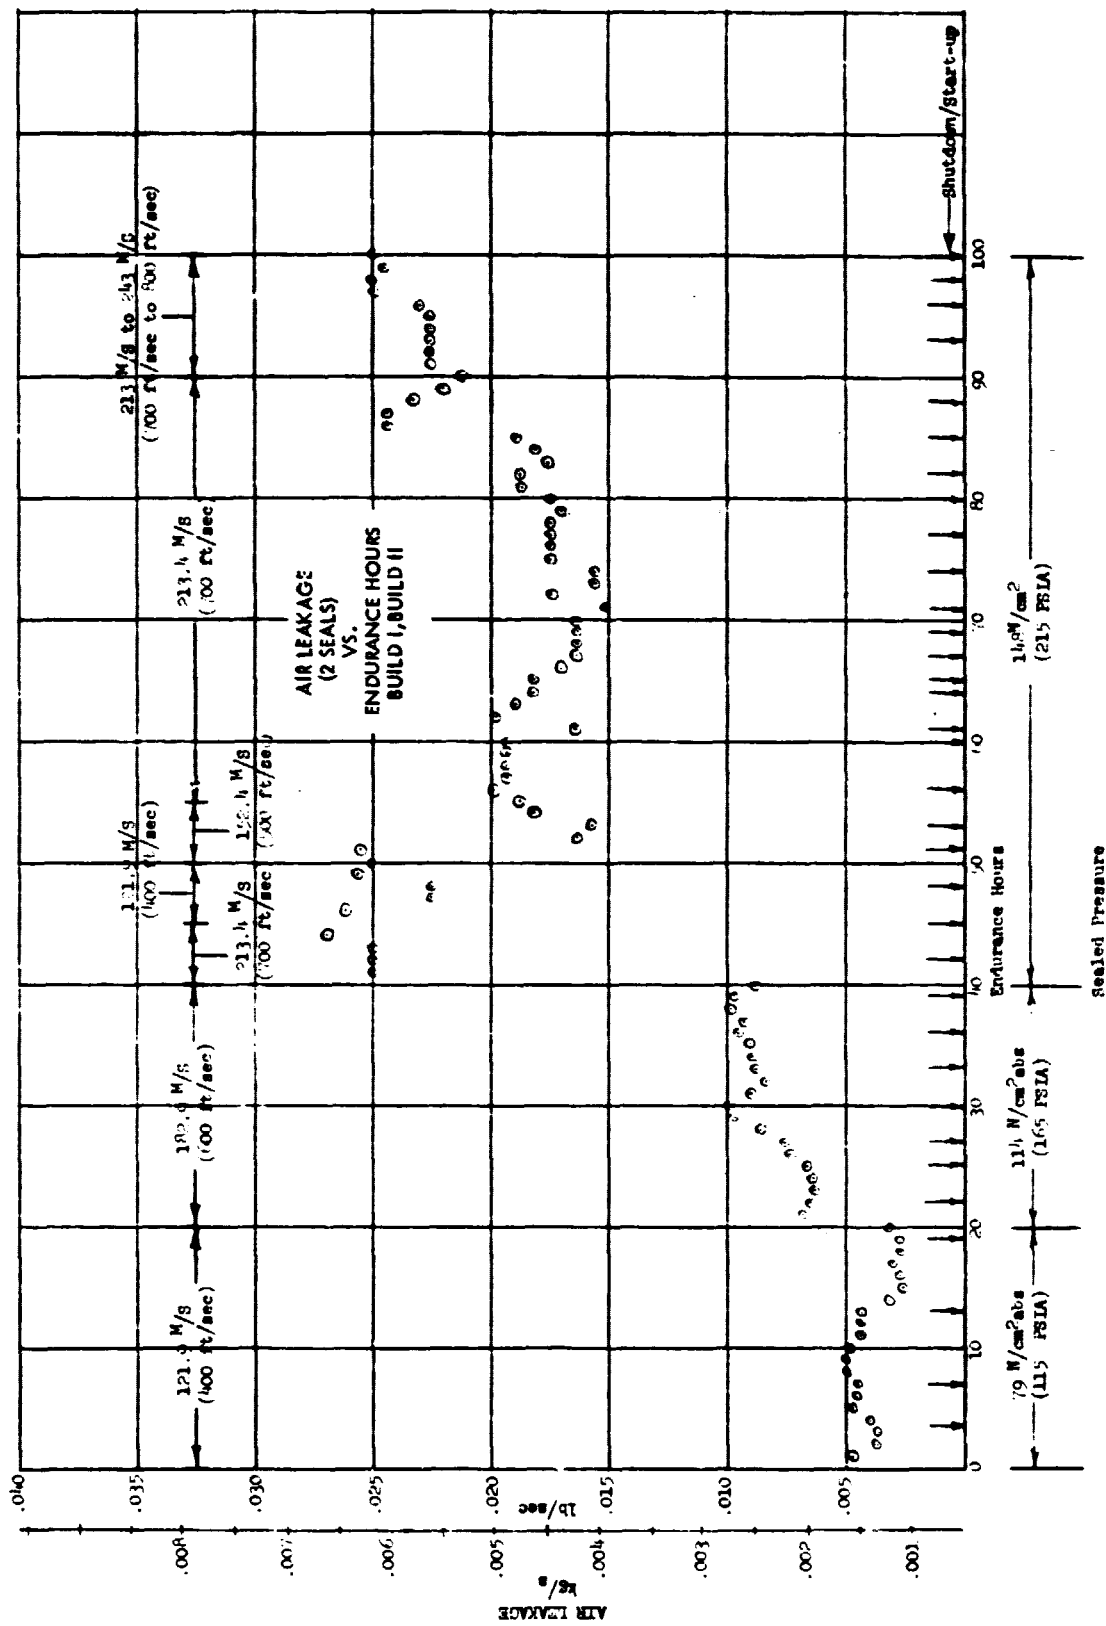
Air leakage was plotted as a function of endurance hours and is presented in Figure 52. Changes in operating parameters are indicated on the plot. What appears to be a disproportionate increase in air leakage is seen prior to the bearing problem during Build I. A 60 percent reduction in air leakage is seen at equivalent conditions after the rebuild (Build II).

Figure 52. Air Leakage Versus Endurance Hours, Build I, Build II.
